NATIONAL RESEARCH COUNCIL
CANADA
DIVISION OF BUILDING RESEARCH

TORNADO WIND DAMAGE TO BUILDINGS OBSERVED
AFTER THE SARNIA TORNADO
of May 21, 1953

by
J.D. McCrea
With a Supplement by D.C. Tibbetts

Report No. 111
of the
Division of Building Research

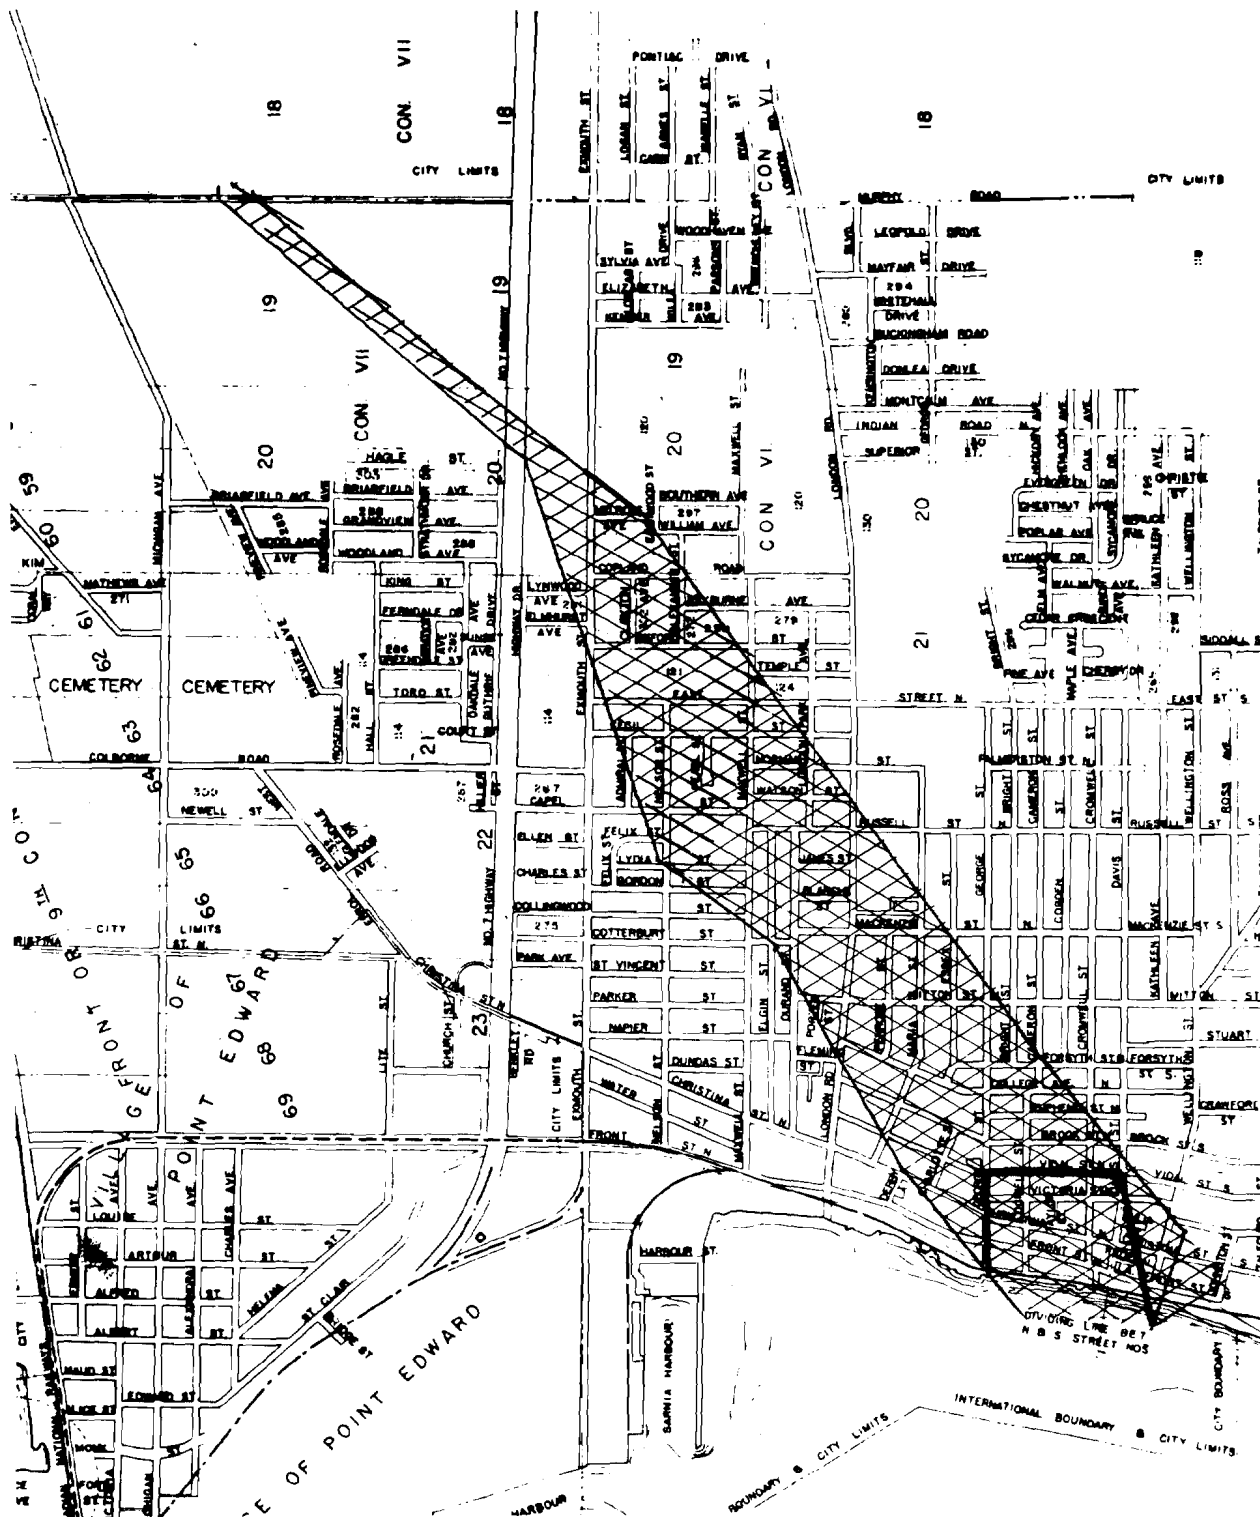
Figure 2 Map of Sarnia showing area affected by storm

Since the storm traced its destructive path through commercial, residential, and agricultural districts, (Fig.2), there was ample opportunity to study its effects on the various types of constructions common to this area of the continent.
